Microplastic Emission from Road Markings in Germany and Austria

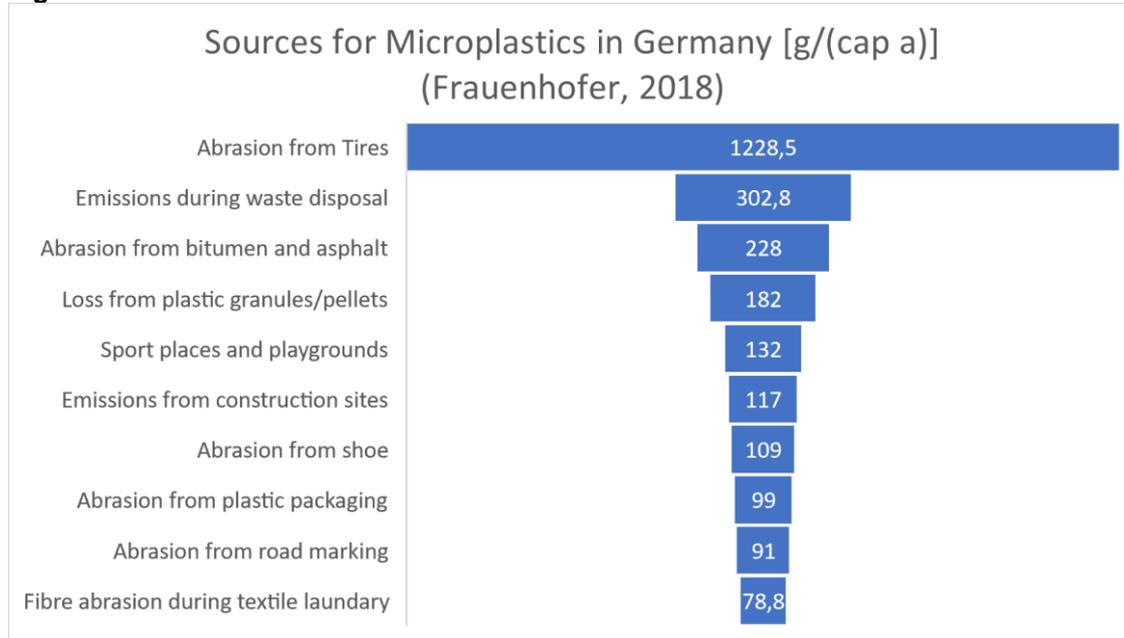
Figure 1

A more recent study by Fraunhofer Intitute concludes that for Germany annually about 91 grams per capita (7.500 tons) of microplastic is originating from road marking abrasion [Kunststoffe in der Umwelt: Mikro- und Makroplastik \(fraunhofer.de\)](#). In comparison to abrasion from tires, which is the biggest source of microplastics with 1228.5 g/(cap a) according to this study, abrasion from road markings generates 13.5 times less microplastic and is ranking no. 9 among the top 10 sources for secondary microplastics in Germany (see figure 1).

Given the fact that about 30.000 tons of road marking materials are typically applied in Germany annually [DSGS 2015] this suggests an abrasion level of 25 % of all material applied annually.

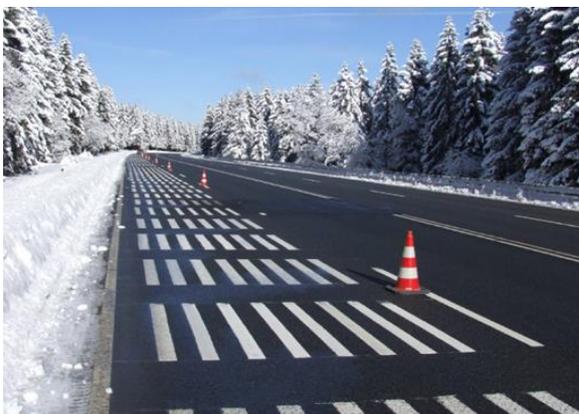
Picture 1 Cold plastic agglomerate road marking after 8 years in service under traffic and snowplow operation at German test field at federal road B4 at Torfhaus (sample 80; applied 30/08/2007)

initial

5 years type II

8 years type I

The findings of Burghardt et al. for Austria, Poland and Croatia are in line with German road marking practice. High presence of cold plastic and thermoplastic materials even after 8 years of service under harsh abrasion conditions has been demonstrated on the German test field at federal road B4 at Torfhaus (see picture 1). The location in the Harz mountains offers the possibility to monitor performance of road marking systems under both traffic of 8000 vehicles per day on average and snowplow abrasion. While paints cannot withstand such abrasion conditions more durable systems, such as cold plastic or tapes or thermoplastic are clearly visible for many years. Recent analysis of abrasion of 91 different road marking samples present at this test field by DSGS revealed that some of these durable materials withstand such harsh abrasion and remain present for more than a decade (see appendix).

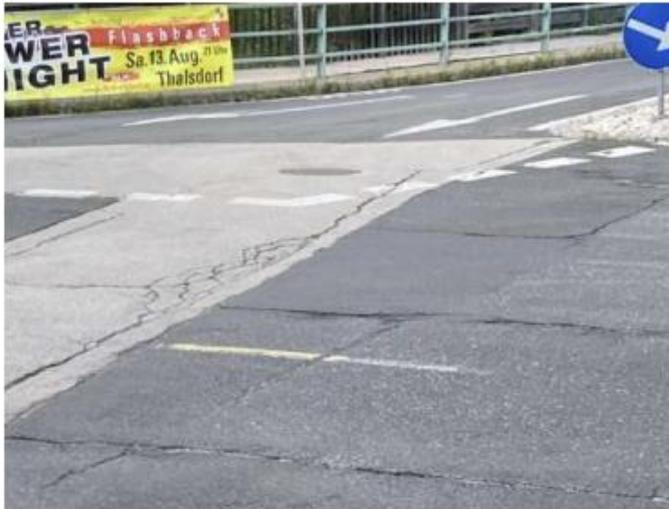
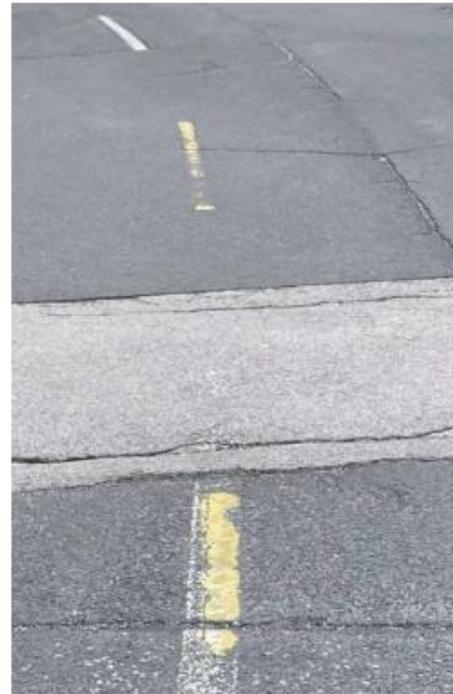
Picture 2 Old yellow cold plastic road markings at an urban junction in Kärnten/Austria installed more than 30 years ago

Proof for abrasion resistance of certain road marking systems can be found on urban Austrian roads. Some yellow cold plastic lines are still occasionally present on busy roads although application of yellow permanent markings had been ceased in 1994 after a revision of Austrian guidelines for road marking application (ZTVÖ). Picture 2 shows an old yellow cold plastic line in the state of Kärnten, which is routinely re-coated with white road marking paint and fresh drop-on glass beads to restore nighttime visibility. Obviously, the paint refreshments do not withstand the traffic and snowplow abrasion in such urban area over winter, but the cold plastic system has been withstanding the wear to a large extend for more than 30 years now.

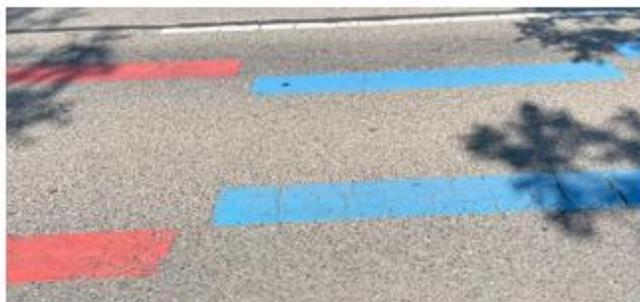
Picture 3 Old road markings at Siemensstraße in Vienna/Austria exposed to an average daily traffic 16000 vehicles

Cold Plastic road markings
after 15 years

Long term monitoring of road marking installations without any interference of re-coating is done at Siemensstraße at Vienna. Here cold plastic road markings are still remaining after more than 20 years of exposure to an average daily traffic load of about 16000 vehicles (see picture 3). This suggests the average annual material loss is less than 4 % of the initially applied cold plastic material at this busy urban road.

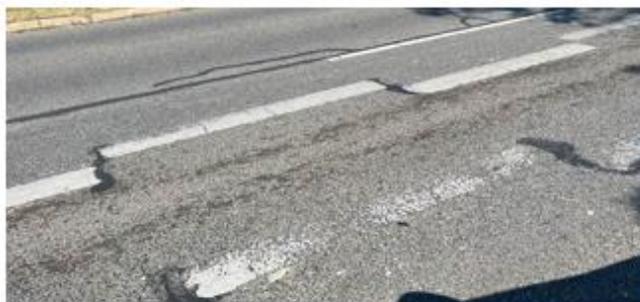
Cold Plastic road markings
after 20-25 years

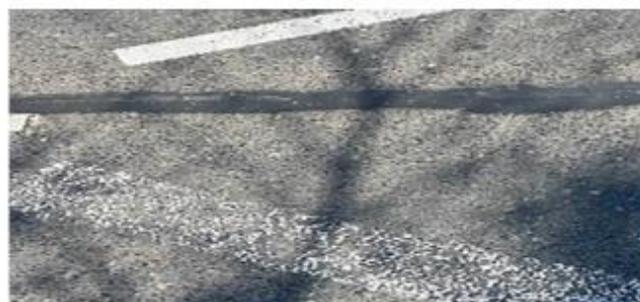
Pre-formed road markings
tape after 10 - 15 years

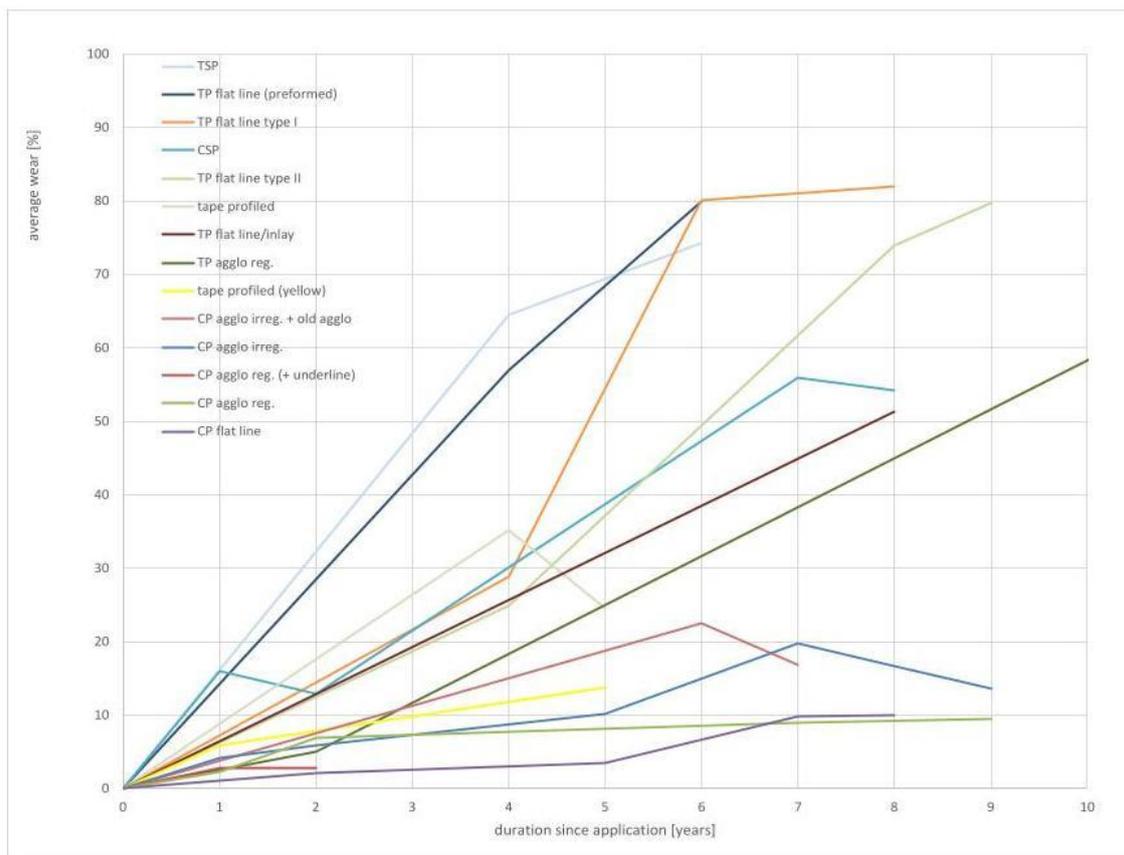
Figure A1 The average wear of various road marking systems versus duration of exposure to traffic and snow plowing at German test field B4. The functional lifetime with respect to mainly nighttime-retroreflectivity of these systems is typically much shorter.

Average wear of different road marking systems on the test field in the Harz Mountains, Germany analyzed by DSGS in September 2022 [Dr. Claudia Drewes, DSGS e. V. 2022 https://dsgs.de/data/CMM_Contents/files/ForsChung-Mitteilungen/Average-wear-of-different-road-marking-systems-2022-10-17.pdf]

DSGS opened this road trial on the federal route B4 in the Harz Mountains near the village of Torfhaus in Germany in September 2006. The average traffic load is about 8.000 vehicles per day. Each sample on the test field consisted of 8 lengthwise stripes according to EN 1824 (Road trials), each stripe was 2 metres long and 15 centimetres wide, the distance between two stripes was 20 centimetres and the gap between two samples was 1 metre. The objective of this test field was to learn which marking materials were suitable for the use in regions where snow plowing and other kinds of winter service takes place. This is why there are commonly used road materials as well as newly developed materials present on the test field. Retroreflectivity and other performance criteria of the individual samples are annually monitored by DSGS. There were 91 samples present on the test field when the annual inspection took place in week 35, 2022. This time additionally the abrasion of the individual samples was evaluated. The following diagram shows the average wear of the corresponding class of road marking material [%] versus the duration of traffic exposure [years] after application on the road, whereby the samples were classified into the following marking systems:
